**Flood Control Project Maintenance
Levee Inspections**

Fall 2010 Levee Maintenance Deficiency Summary Report

Reclamation District No. 1001 Nicolaus

Levee Inspection Report By Mile - Fall 2010

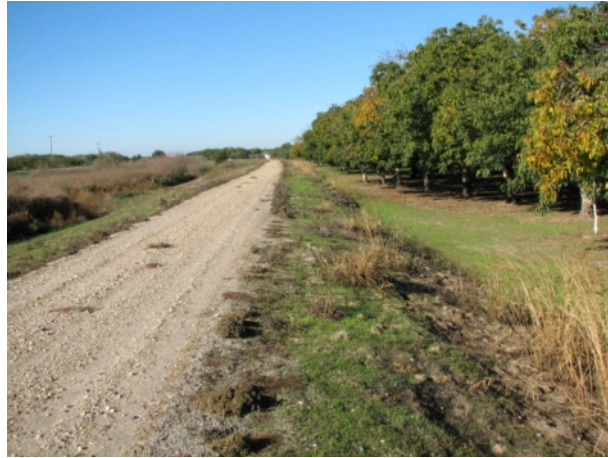
Levee Mile Report Line	1
Start Levee Mile	0.65
End Levee Mile	4.15
Location	Water Side
Category	Earthen Levee
Item	Vegetation
Levee mile 0.65, water side vegetation.	
cathom_f_20101108_185.jpg

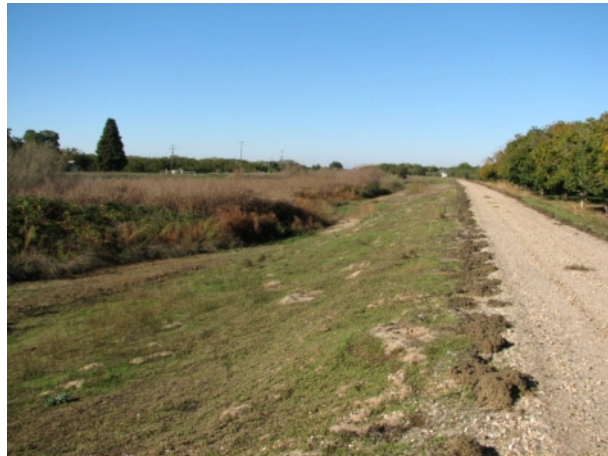
Levee Mile Report Line	2
Start Levee Mile	0.65
End Levee Mile	4.15
Location	Land Side
Category	Earthen Levee
Item	Vegetation
Levee mile 0.65, land side vegetation.	
cathom_f_20101108_186.jpg

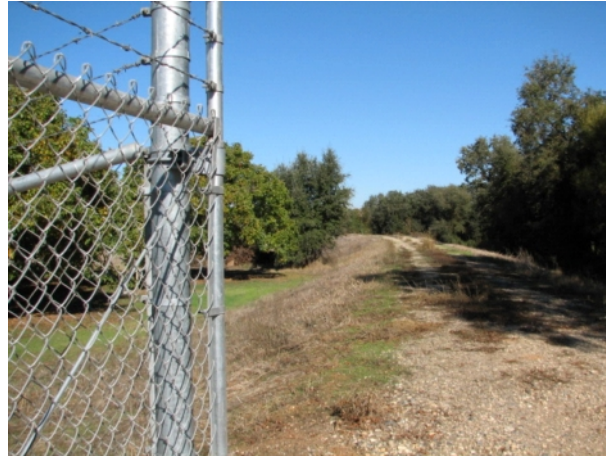
Levee Mile Report Line	1
Start Levee Mile	0.00
End Levee Mile	3.66
Location	Land Side
Category	Earthen Levee
Item	Vegetation
Levee mile 0.00, land side vegetation.	
cathom_f_20101108_187.jpg

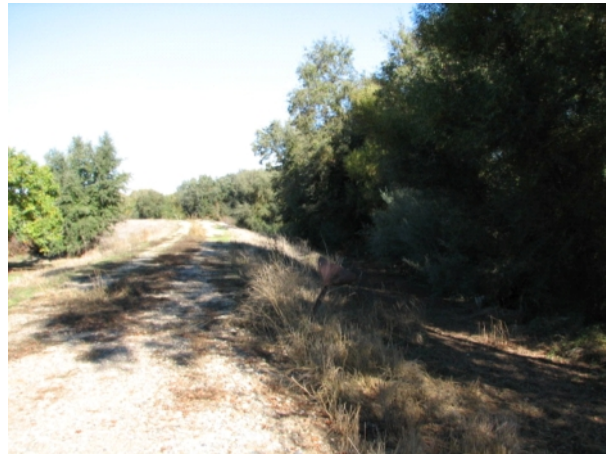
Levee Mile Report Line	2
Start Levee Mile	0.22
End Levee Mile	3.66
Location	Water Side
Category	Earthen Levee
Item	Vegetation
Levee mile 0.00, water side vegetation.	
cathom_f_20101108_188.jpg

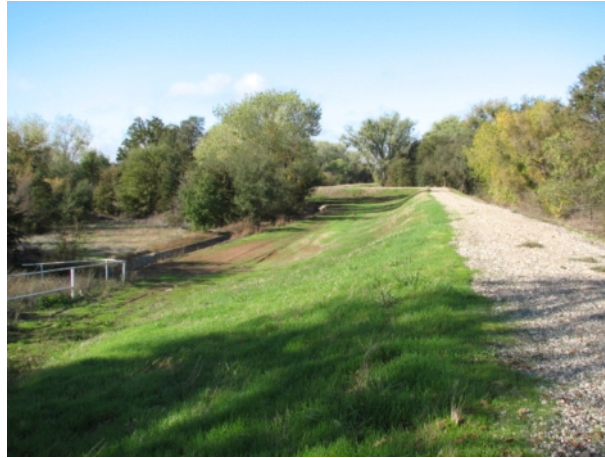
Levee mile 0.00, land side vegetation.

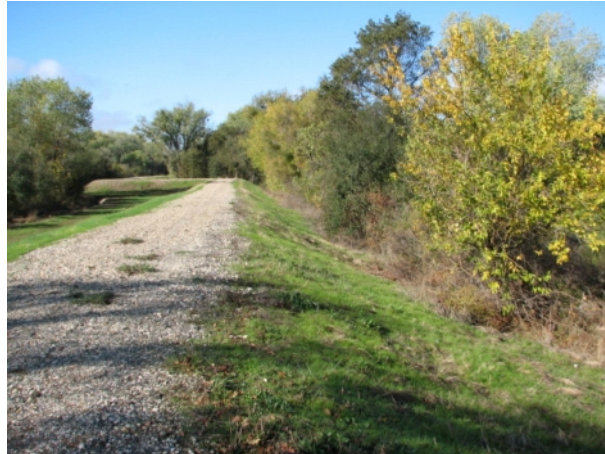
Levee Mile Report Line	2
Start Levee Mile	0.00
End Levee Mile	12.60
Location	Water Side
Category	Earthen Levee
Item	Vegetation

Levee mile 0.00, water side vegetation.

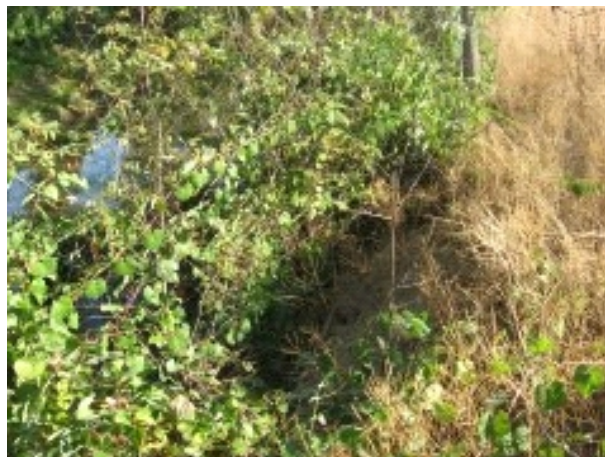
Levee Mile Report Line	19
Start Levee Mile	12.16
End Levee Mile	12.22
Location	Water Side
Category	Supplemental
Item	USACE Erosion Survey

2009: 15 ft berm, 1:1 slope, tree hazards, holes, slumping, and seepage, clays and silts, 2.84 ft/s
[2009 SiteID:BER_0-8_L]

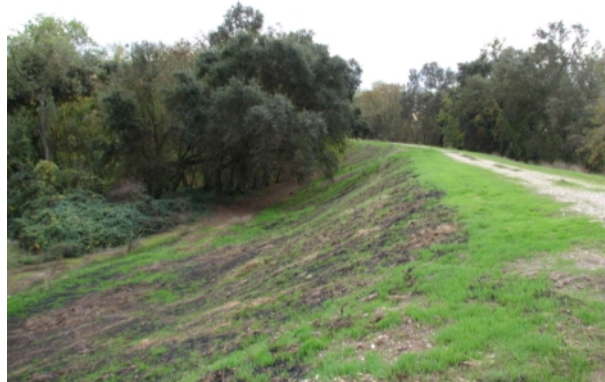
Levee Mile Report Line	1
Start Levee Mile	0.02
End Levee Mile	13.31
Location	Land Side
Category	Earthen Levee
Item	Vegetation
Levee mile 0.00, land side vegetation.	
cathom_f_20101115_198.jpg

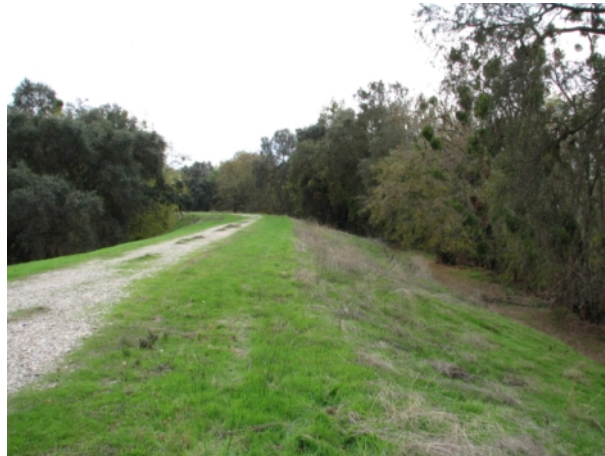
Levee Mile Report Line	2
Start Levee Mile	0.02
End Levee Mile	13.31
Location	Water Side
Category	Earthen Levee
Item	Vegetation
Levee mile 0.00, water side vegetation.	
cathom_f_20101115_199.jpg

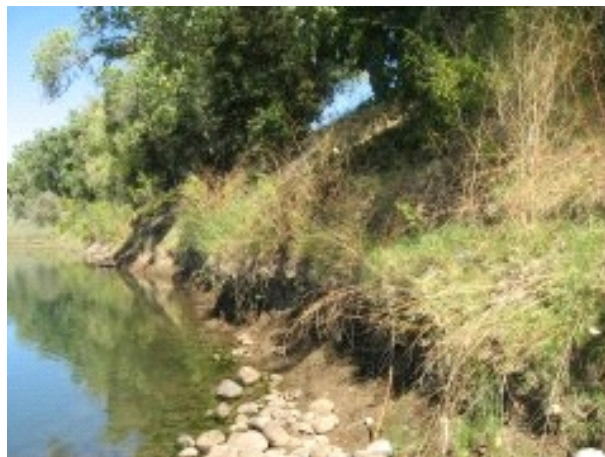
Levee Mile Report Line	7
Start Levee Mile	5.42
End Levee Mile	5.51
Location	Water Side
Category	Supplemental
Item	USACE Erosion Survey
2009: 5 ft berm, 2.5:1 slope, tree hazards, seepage, and slumping, sands and silts, 9.97 ft/s [2009 SiteID:FHR_7-0_L]	
cathom_f_20100928_030.JPG

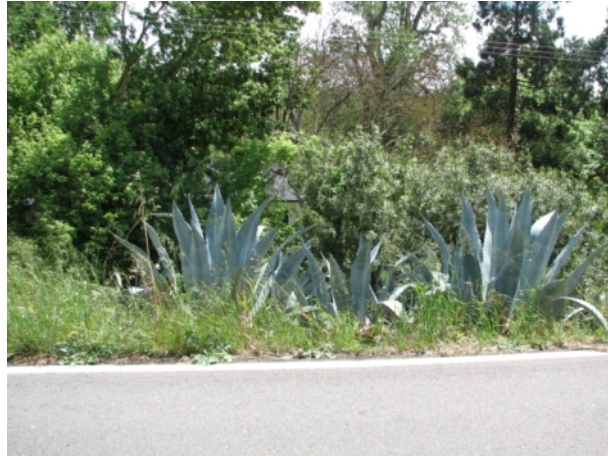
Levee Mile Report Line	8
Start Levee Mile	6.48
End Levee Mile	6.48
Location	Land Side
Category	Earthen Levee
Item	Encroachments
Landscaping on the land side shoulder and slope levee mile 6.48.	
cathom_f_20100928_033.jpg

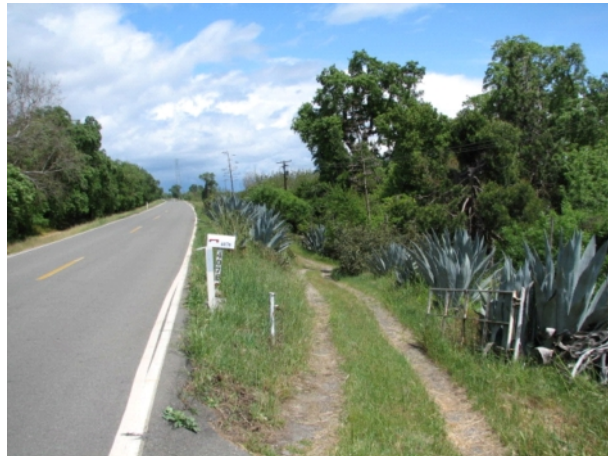
Levee Mile Report Line	8
Start Levee Mile	6.48
End Levee Mile	6.48
Location	Land Side
Category	Earthen Levee
Item	Encroachments
Landscaping levee mile 6.48.	
cathom_f_20100928_034.jpg

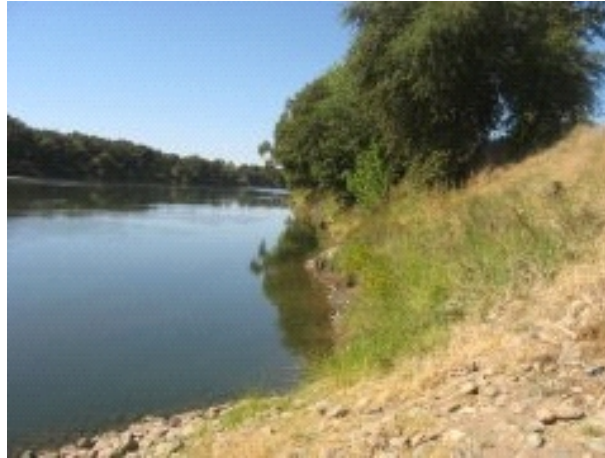
Levee Mile Report Line	15
Start Levee Mile	11.80
End Levee Mile	11.83
Location	Water Side
Category	Supplemental
Item	USACE Erosion Survey
2009: 15 ft berm, 2.5:1 slope, tree hazards, seepage, and slumping, sands and cobbles, 4.8 ft/s [2009 SiteID:FHR_0-6_L]	
cathom_f_20100928_032.JPG

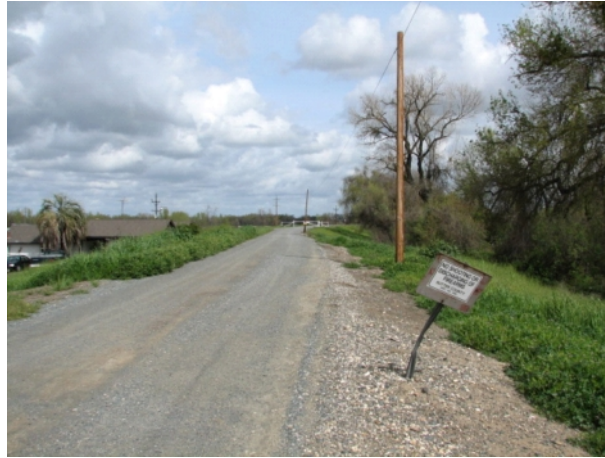
Poles on the water side shoulder levee mile 0.00 - 0.75

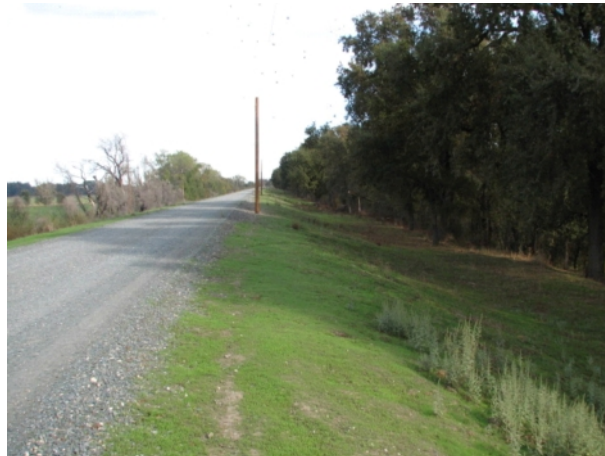
Levee Mile Report Line	2
Start Levee Mile	0.02
End Levee Mile	5.44
Location	Water Side
Category	Earthen Levee
Item	Vegetation

Levee mile 0.00, water side vegetation.

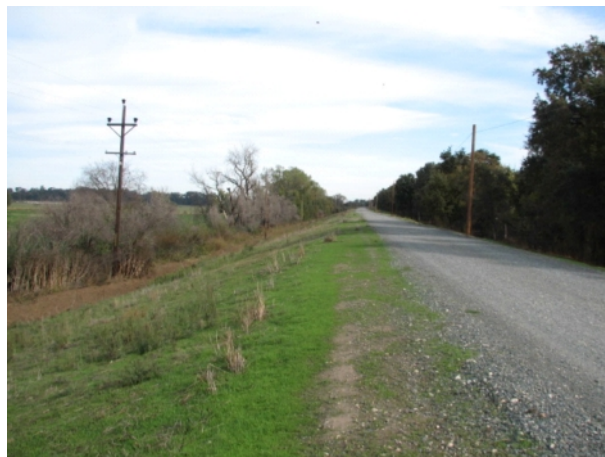
Levee Mile Report Line	3
Start Levee Mile	0.02
End Levee Mile	5.44
Location	Land Side
Category	Earthen Levee
Item	Vegetation

Levee mile 0.00, land side vegetation.

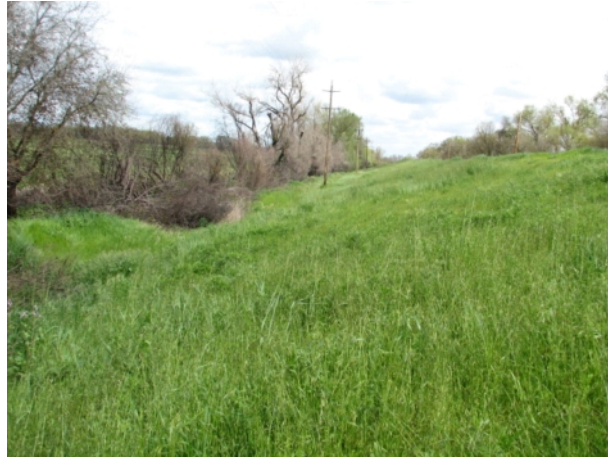
Poles at the land side toe levee mile 0.19 - 0.86.

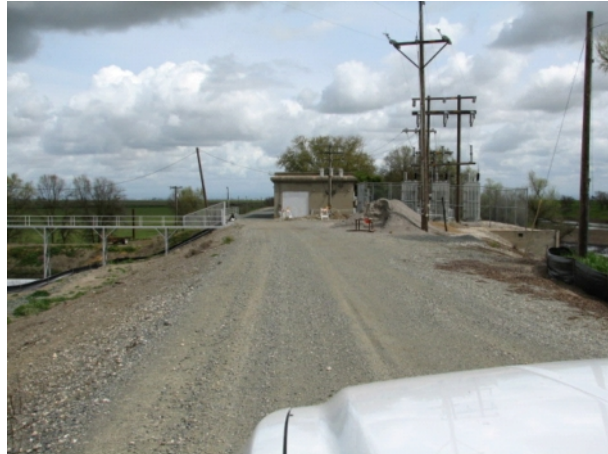
Levee Mile Report Line	5
Start Levee Mile	0.83
End Levee Mile	0.83
Location	Water Side
Category	Earthen Levee
Item	Encroachments

Pump house on the water side levee mile 0.83.

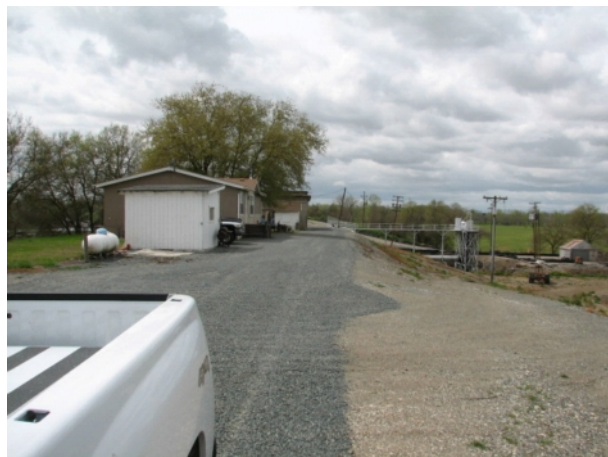
Levee Mile Report Line	5
Start Levee Mile	0.83
End Levee Mile	0.83
Location	Water Side
Category	Earthen Levee
Item	Encroachments

Pump house and Caretakers home levee mile 0.83

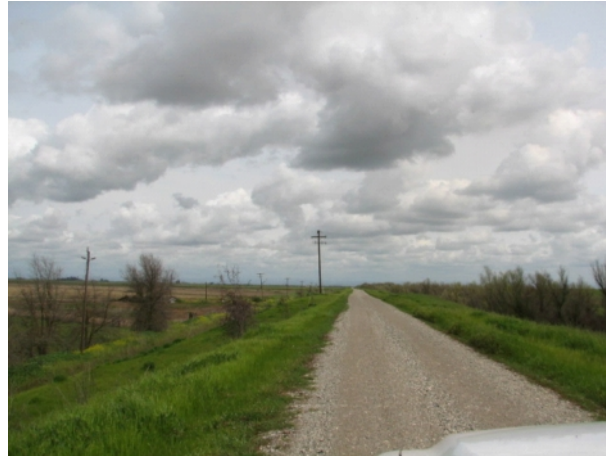
Levee Mile Report Line	6
Start Levee Mile	1.15
End Levee Mile	1.15
Location	Land Side
Category	Earthen Levee
Item	Encroachments
Pole on land side shoulder levee mile 1.15.	
cathom_f_20100928_039.jpg

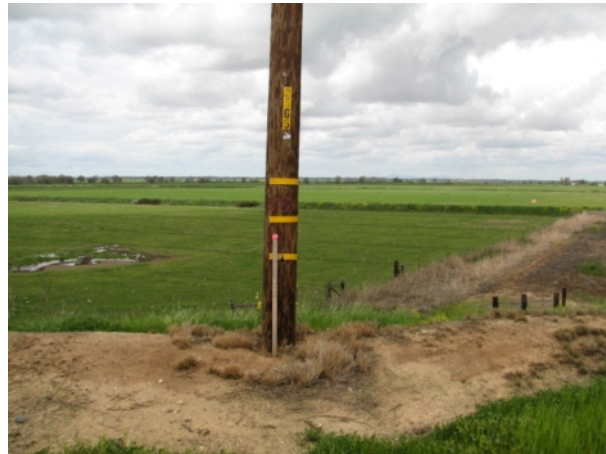
Levee Mile Report Line	6
Start Levee Mile	1.15
End Levee Mile	1.15
Location	Land Side
Category	Earthen Levee
Item	Encroachments
Pole on land side shoulder.	
cathom_f_20100928_040.jpg

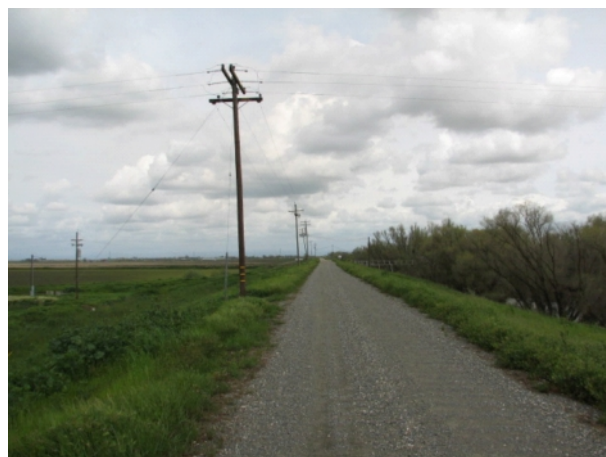
Levee Mile Report Line	7
Start Levee Mile	3.59
End Levee Mile	3.85
Location	Land Side
Category	Earthen Levee
Item	Encroachments
Poles on the land side shoulder levee mile 3.59 - 3.85.	
cathom_f_20100928_041.jpg

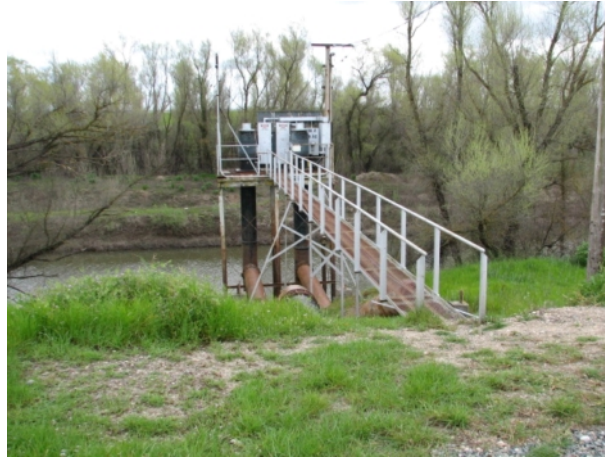
Pump water side levee mile 3.69.

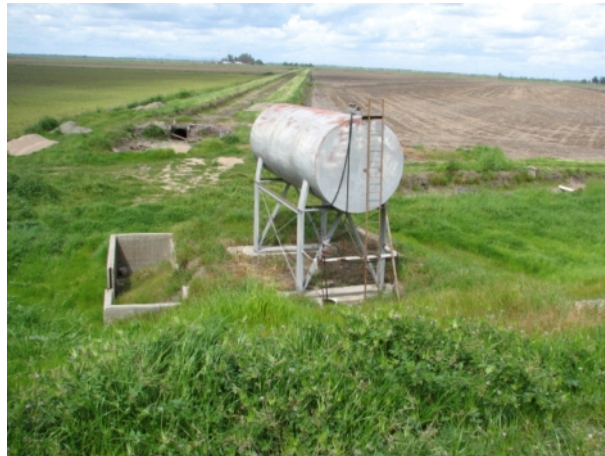
Levee Mile Report Line	11
Start Levee Mile	3.85
End Levee Mile	3.85
Location	Land Side
Category	Earthen Levee
Item	Encroachments

Storage tank on land side slope levee mile 3.85.

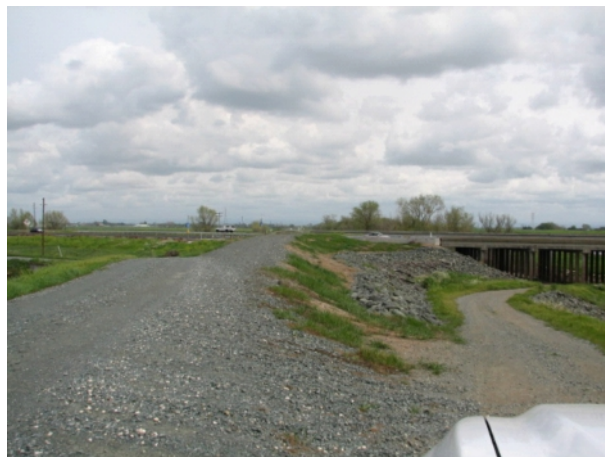
Levee Mile Report Line	12
Start Levee Mile	4.44
End Levee Mile	4.44
Location	Crown
Category	Earthen Levee
Item	Encroachments

Levee stops at hwy 70 and starts again on the other side of hwy 70.

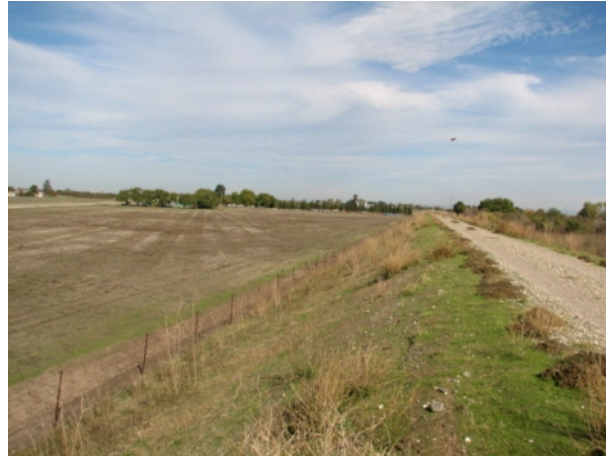
Levee Mile Report Line	1
Start Levee Mile	0.09
End Levee Mile	4.73
Location	Land Side
Category	Earthen Levee
Item	Vegetation
Levee mile 0.00, land side vegetation.	
cathom_f_20101108_191.jpg

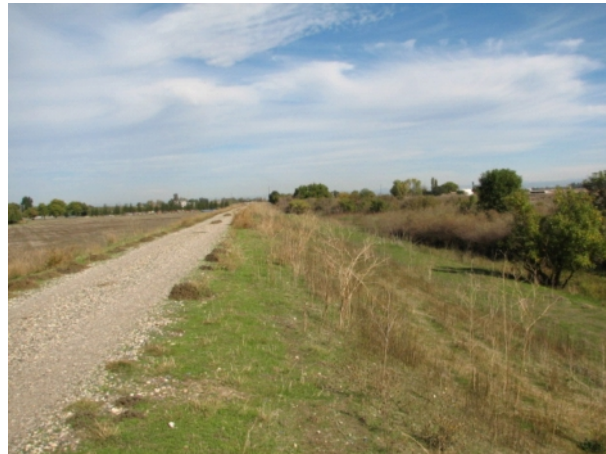
Levee Mile Report Line	2
Start Levee Mile	0.09
End Levee Mile	4.73
Location	Water Side
Category	Earthen Levee
Item	Vegetation
Levee mile 0.00, water side vegetation.	
cathom_f_20101108_192.jpg

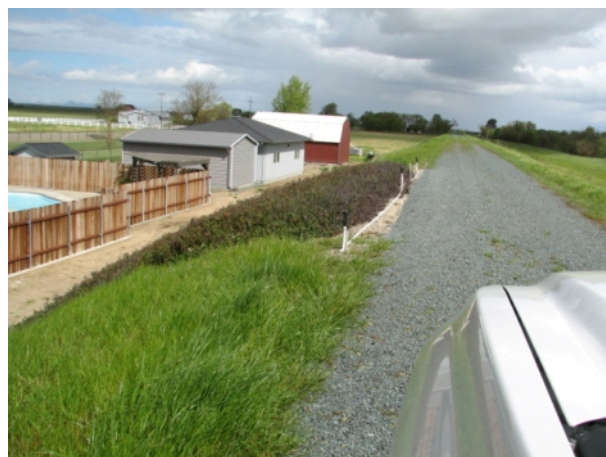
Levee Mile Report Line	3
Start Levee Mile	1.06
End Levee Mile	1.06
Location	Land Side
Category	Earthen Levee
Item	Encroachments
Landscaping on the land side slope L/M 1.06.	
cathom_f_20100928_046.jpg

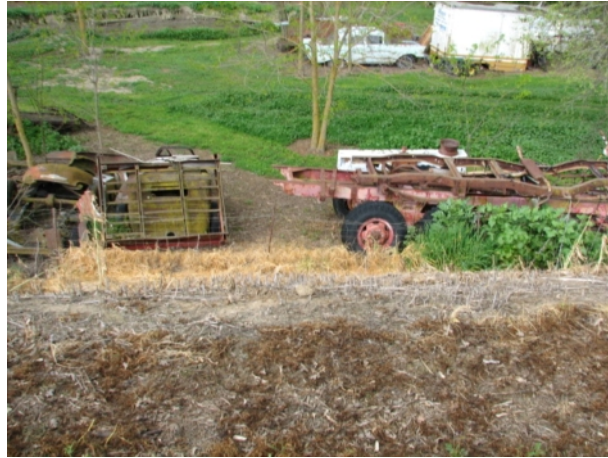
Levee Mile Report Line	4
Start Levee Mile	1.37
End Levee Mile	1.37
Location	Land Side
Category	Earthen Levee
Item	Encroachments
Equipment at the land side toe L/M 1.37.	
cathom_f_20100928_047.jpg

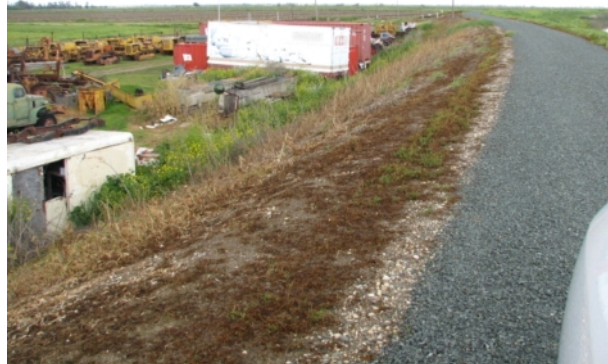
Levee Mile Report Line	5
Start Levee Mile	1.45
End Levee Mile	1.45
Location	Land Side
Category	Earthen Levee
Item	Encroachments
Equipment at the land side toe L/M 1.45.	
cathom_f_20100928_045.jpg
